AFRL-RH-WP-TR-2012-0103

**ASSESSMENT OF CARGO SPACE SEATING
PERFORMANCE APPLICABLE TO PAVE HAWK AND
BLACK HAWK AIRCRAFT DURING HELICOPTER
MISHAPS**

**June 2012
Interim Report**

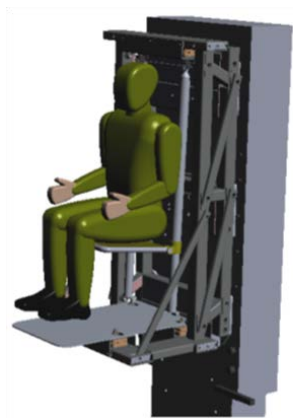
Figure 4. Pure Vertical

(3) Pure Vertical (PV) – The seats has no offset relative to the positive z-axis acceleration pulse. The orientation is shown in Figure 4.

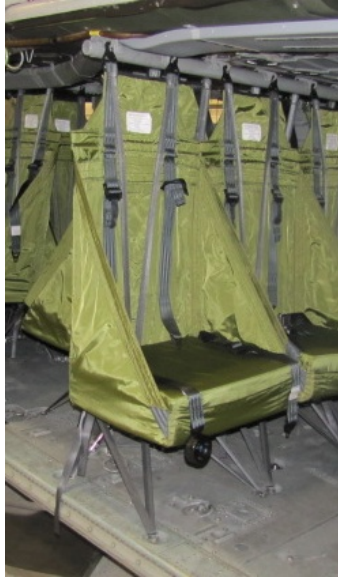
Figure 7. Glatz Aeronautical Prototype Seat

The Glatz Aeronautical Prototype seat was partially developed under an Air Force Research Laboratory (AFRL) Phase I Small Business Innovative Research (SBIR) program. The seat delivered to AFRL for testing is called the “Next Generation Troop Seat (NGTS) Mrk5Mod1A”. The seat was modified during testing with stronger seat floor mounts and additional structure for higher energy tests. The modified seat is called the NGTS Mrk5Mod1B. Both variants will be called the “Glatz seat” in this paper and any modifications to the seat are noted in the individual test notes. The seat is unconventional in that it has limited hard structure and consists of a large foam seat pan with fabric side supports (Figure 7). The seat hangs from H-60A/L seat supports and has 1-inch webbing to secure the seat structure to the floor. All seats were purchased new. The seat is in development and does not represent a finalized design.

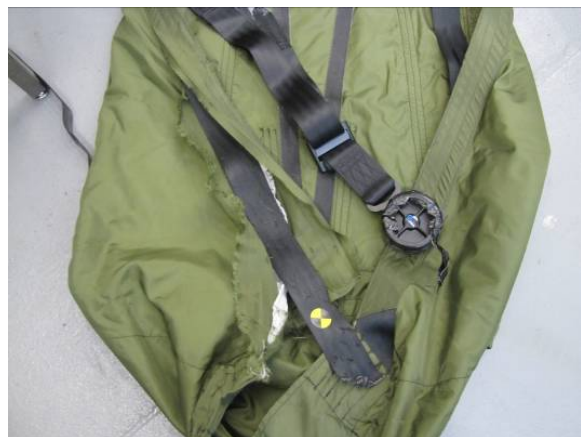
VDT6223 – Cell B, CV, Glatz, LOIS, 35.26G, 48.37ft/s, 25.4ms rise time

VDT6223 was a structural failure of the seat. The front right webbing that held the seat cushion ripped and allowed the seat cushion and manikin to submarine. The right lap restraint belt ripped free from the seat structure. The manikin was ultimately hung by the torso restraints still

attached to the buckle. The cause of the seat structure ripping was due to a manufacturing error according to Glatz Aeronautical. Fixes to the seat were applied to tests VDT6256 and HIA8510 by lengthening the structural webbing further around the front of the seat pan. Also, the lap restraint belts were lengthened behind the seat pan in later tests to prevent the complete separation of the lap belt from the seat. Seat attachment points were again deformed but did not break. A peak lumbar Z force of 1153 lb was recorded, though comparison to other testing is not valid due to structural failure of the seat.

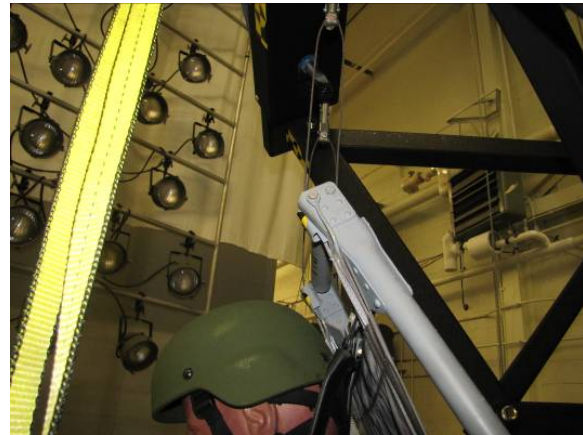
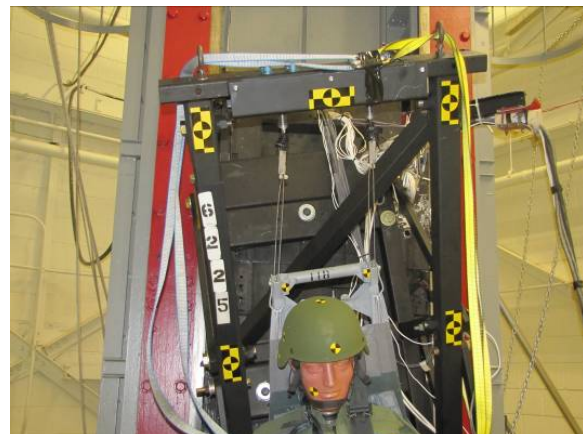
VDT6225 – Cell D, CV, H-60A/L forward-facing, LARD, 36.67G, 48.96ft/s, 24.7ms rise time

VDT6225 was the first test at the high energy level with LARD. The feet of the manikin remained on the floor during the impact. The seat pan fabric ripped from side to side during the impact. The seat stroked 10” on the left and 10.25” on the right. All mounting points remained secured to the fixture. The seat pan strut extended during the impact 2.125”. A peak lumbar Z force of 778 lb was recorded during the test. This force is relatively low most likely due to the seat pan ripping. The seat pan X and Z accelerometers were broken during the test. All the remaining data channels were successfully collected. The restraint buckle disengaged with 36 lb force.

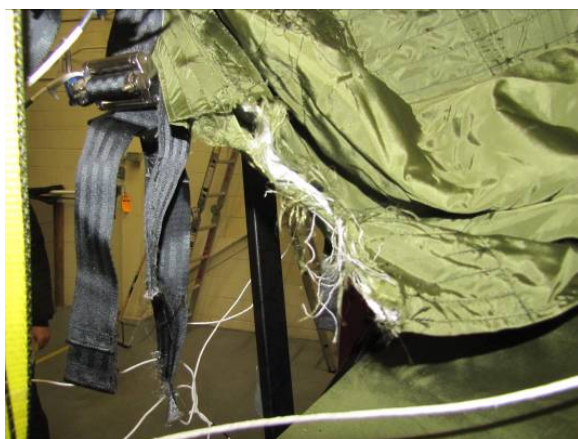
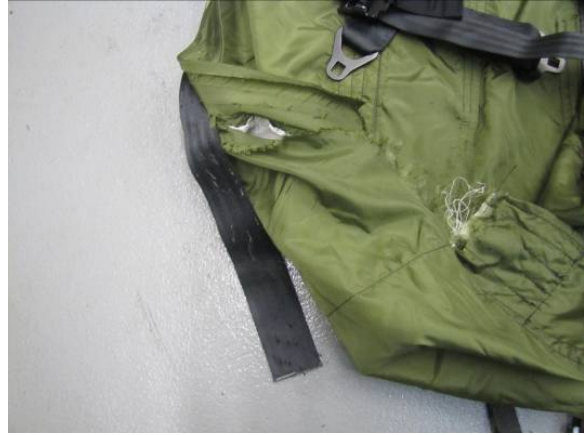
VDT6226 – Cell C, CV, Glatz, LARD, 25.82G, 40.48ft/s, 28.9ms rise time

VDT6226 was the first test with LARD in the Glatz seat. The seat structurally failed in multiple places, causing the manikin to be completely unrestrained in the seat. During impact the manikin submarined and was momentarily hung by the torso belts still attached to the rotary buckle. The right rear side webbing pulled out of the seat structure. The front right seat pan structure ripped. This was again due to manufacturer error, according to Glatz Aeronautical. The original aluminum mounting feet used during the first two Glatz tests with LOIS were replaced with stainless steel feet. The new feet did not show any signs of deformation. Both lap belts ripped from the seat. There was an Nij tension-flexion value of 0.6815, or equivalent to a 22% probability of an AIS ≥ 2 neck injury. Since the seat structurally failed, lumbar load and seat pan acceleration are meaningless and are not comparable to other seat tests. The left torso restraint belt force channel went bad well after the impact. All other data were successfully recorded. The restraint buckle disengaged with 9 lb force.

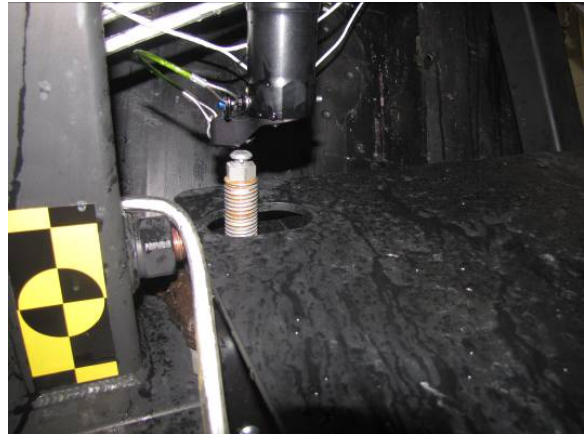
VDT6227 – Cell C, CV, UH-60M, LARD, 25.56G, 40.53ft/s, 29.1ms rise time

VDT6227 was the first LARD test with the UH-60M seat. The right foot of the seat disengaged during the impact. After further inspection it was found there was some interference with the AFRL mounting points and that the foot may have not been fully engaged. A modification to the mounting bracket was made after VDT6228, and in subsequent tests, the feet stayed attached. Even with the foot becoming disengaged, the seat stroked 4.625". The only structural damage observed was slight deformation in the seat pan. A peak lumbar Z force of 1346 lb was recorded. All data were successfully collected. The restraint buckle disengaged with 8 lb force.

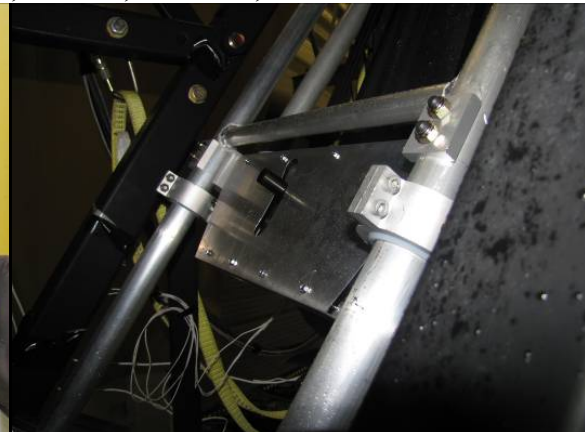
VDT6232 – Cell B, CV, Wolf, LOIS, 35.24G, 48.33ft/s, 25.7ms rise time

VDT6232 was the last test with the Wolf seat in the CV orientation. As with VDT6231, changes were incorporated to both the top and lower mounts of the seat to the fixture. The seat locking mechanism that prevents stroking appears to have disengaged. Similar to VDT6231, the seat did not stroke during impact. A peak lumbar Z force of 2032 lb was recorded. The top hanger bent during the impact, though this was the only structural damage seen on the seat. All data were collected successfully. The restraint buckle disengaged with 13.5 lb of force.

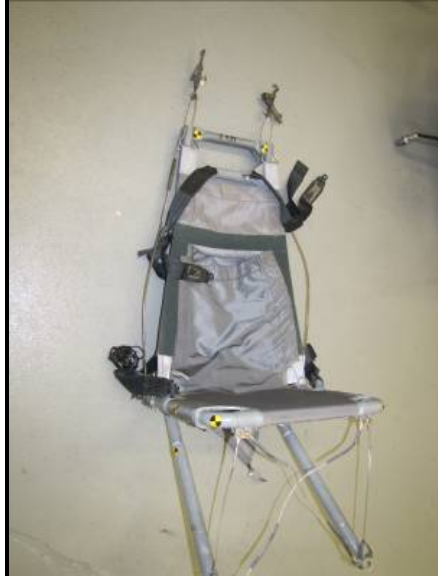
VDT6233 – Cell A, CV, H-60A/L aft-facing, LOIS, 23.23G, 38.56ft/s, 30.2ms rise time

VDT6233 was the first test of the H-60A/L aft-facing seat. The top mounting hooks were wrapped with tape and secured with zip-ties, preventing inadvertent release during rebound after the primary impact. All mounting points successfully stayed attached during impact. The seat stroked 3.5”. The manikin did sink into the backpack pouch. No other structural damage was noted on the seat. A peak lumbar Z force of 602 lb was recorded. All data were successfully collected. The restraint buckle disengaged with 29 lb of force.

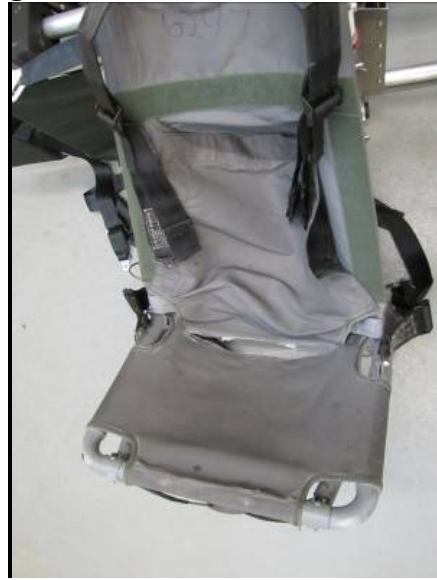
VDT6247 – Cell H, PV, H-60A/L forward-facing, LOIS, 33.91G, 46.25ft/s, 26.5ms rise time

VDT6247 was the last PV with LOIS using the H-60A/L seat. The seat stroked 3.25" during impact. The rear of the seat pan ripped, though the manikin was successfully held in the seat. Lap belt tension was not recorded during the test due to available belt length. A very short Z acceleration of 54.75G was recorded. A peak lumbar Z force of 1104 lb during the impact as well as a 31.03G peak chest resultant acceleration were observed. An Nij tension-extension of 0.5763 was calculated, resulting in a 20% probability of an AIS ≥ 2 neck injury. The restraint buckle released with 9 lb of force.

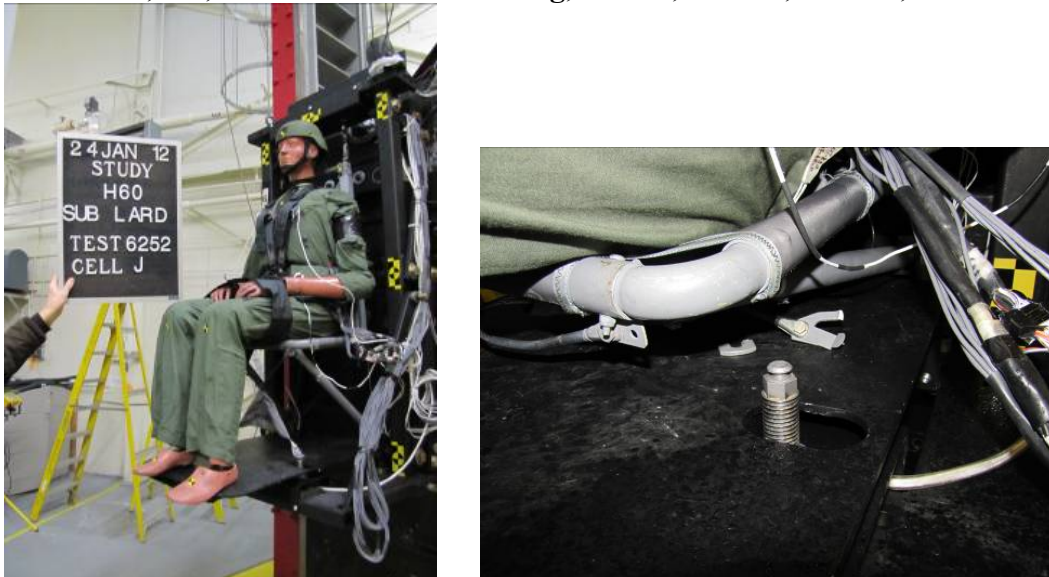
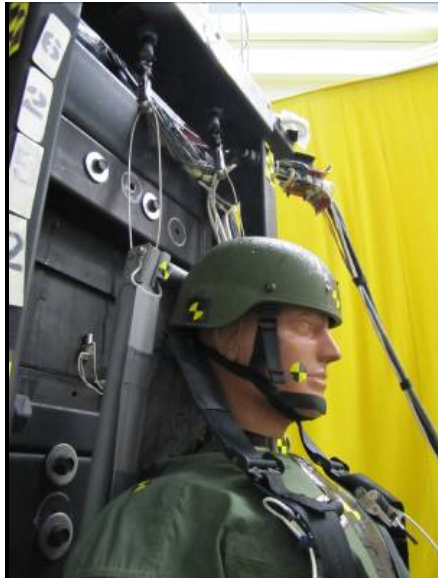
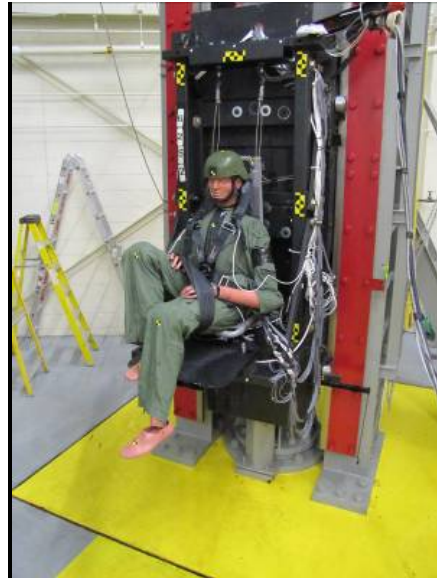
VDT6252 – Cell J, PV, H-60A/L Forward-facing, LARD, 34.92G, 46.9ft/s, 26.4ms rise time

VDT6252 was the last PV test with the H-60A/L seat. The seat stroked 11.75in. There was significant tearing of the right side of the seat pan along the seat pan structure. The front left mounting point failed and tore away. The bottom left front mounting Y force channel was bad during the test. The lumbar moment about the Y axis peaked at the set range of the channel. A peak chest acceleration resultant of 45.19G was recorded along with a peak lumbar Z force of 1752 lb. A seat pan acceleration of 37.41G was recorded during the pulse, and a higher 72.81G was recorded soon after. This was most likely due to the ripping and subsequent bottoming out of the seat on the fixture, and was consistent with the peak lumbar forces recorded. No neck injury criteria were exceeded. The restraint buckle released with 15 lb of force.

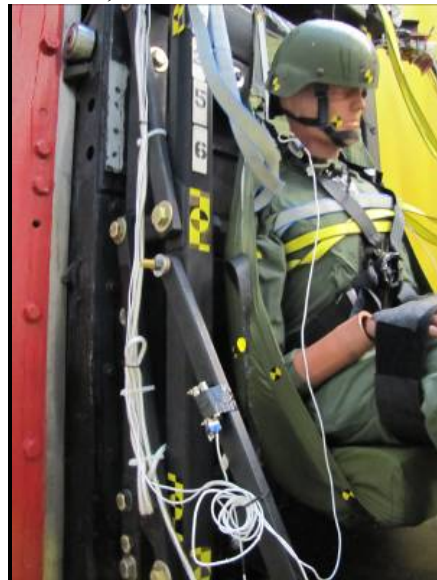
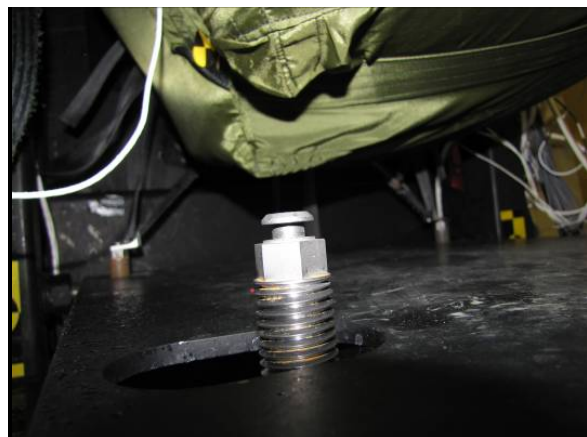
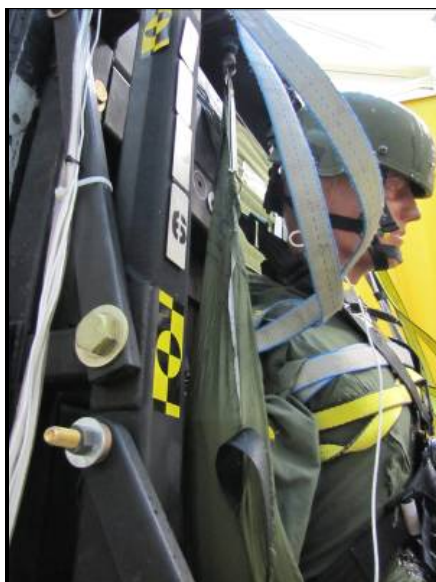
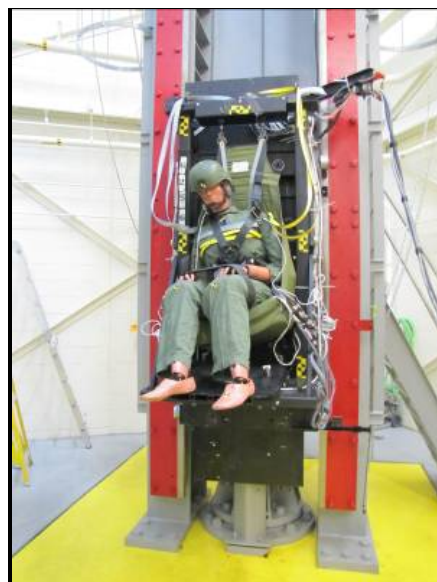
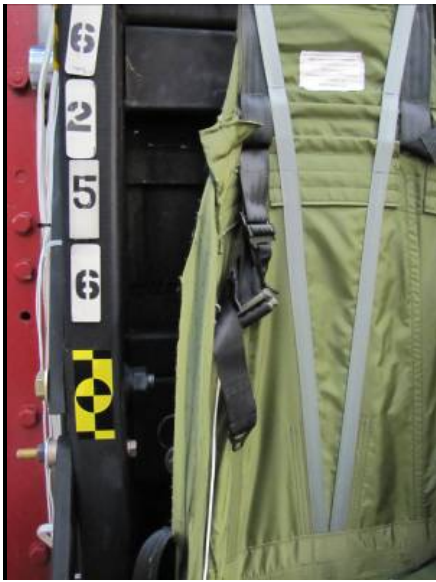
VDT6256 – Cell J, PV, Glatz, LARD, 34.99G, 46.85ft/s, 26.4ms rise time

VDT6256 used a modified Glatz seat. Additional webbing was placed on the back of the seat, the structural webbing down the side panel of the seat was extended around the front of the seat pan, and the lap belt webbing was extended behind the seat pan. The lap belt forces were not collected due to space and length of available belts. All other data channels were successfully collected. During impact the webbing to the front feet came loose as the seat pan descended and put tension on the webbing. The seat cushion started to come of the seat bucket, and the structural webbing on the right side panel ripped out. The back of the seat pan ripped, and the lap belts ripped out of the seat back. One of the tension rods at the top of the seat broke. A peak chest acceleration resultant of 44.34G was recorded along with a peak lumbar Z force of 1251 lb. The seat pan acceleration Z was noisy – most likely due to stitching in the seat coming out. A peak seat cushion Z acceleration of 21.86G was recorded. No neck injury criteria were exceeded. The restraint buckle released with 4.5 lbs.

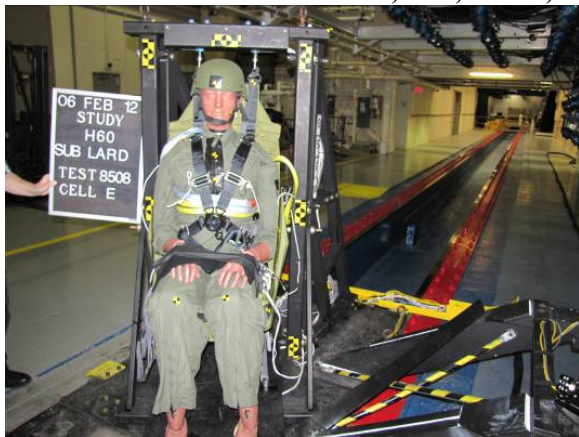
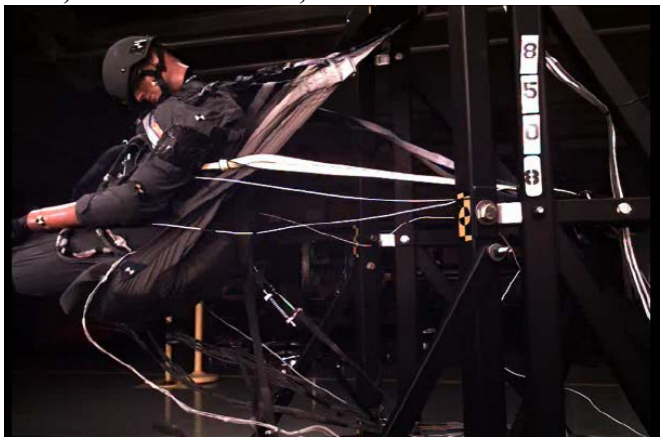
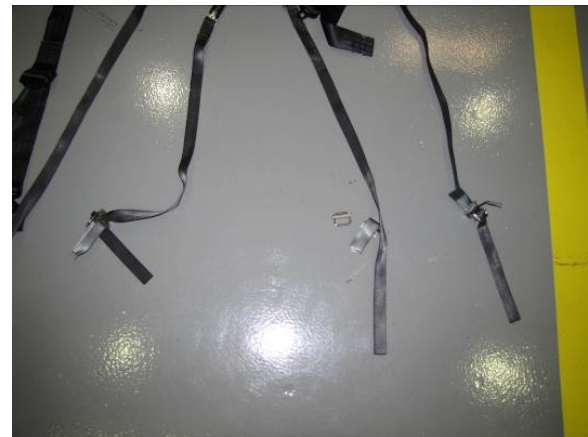
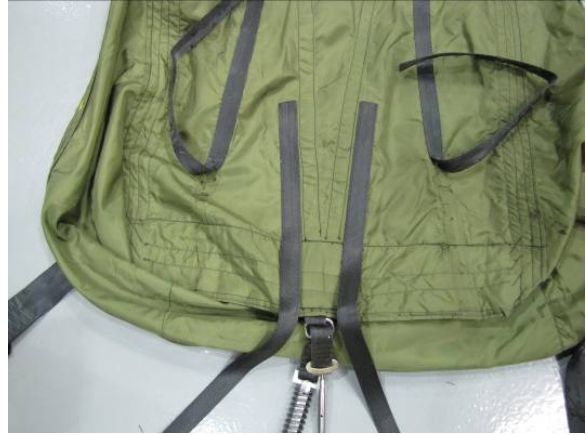
HIA8508 – Cell E, CH, Glatz, LARD, 18.05G 46.15ft/s, 71ms rise time

HIA8508 was the first CH test with the Glatz seat. The lumbar My channel maxed out. The seat was the standard seat without the modifications added for VDT6256. As the seat moved towards the piston during the impact, the back webbing straps broke loose from the seat. When this occurred the seat pan essentially had no connection with the steel floor mounting points and the
